# BAY AVENUE, BRIDGE OVER MILL CREEK

STAFFORD, OCEAN COUNTY  
PUBLIC INFORMATION CENTER

| August 3, 2026

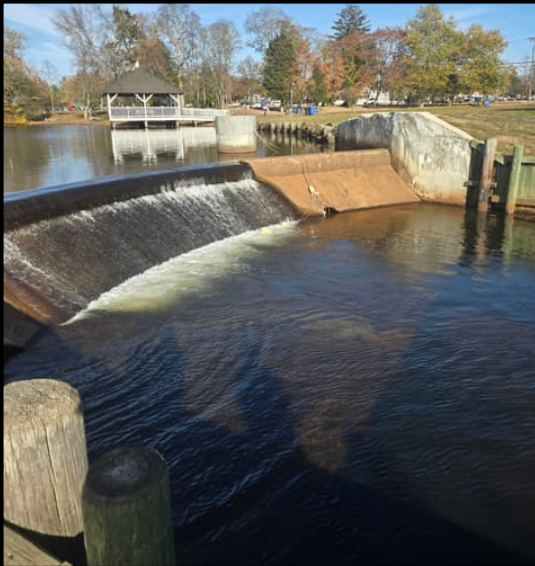
**SPILLWAY LOOKING NORTHEAST**

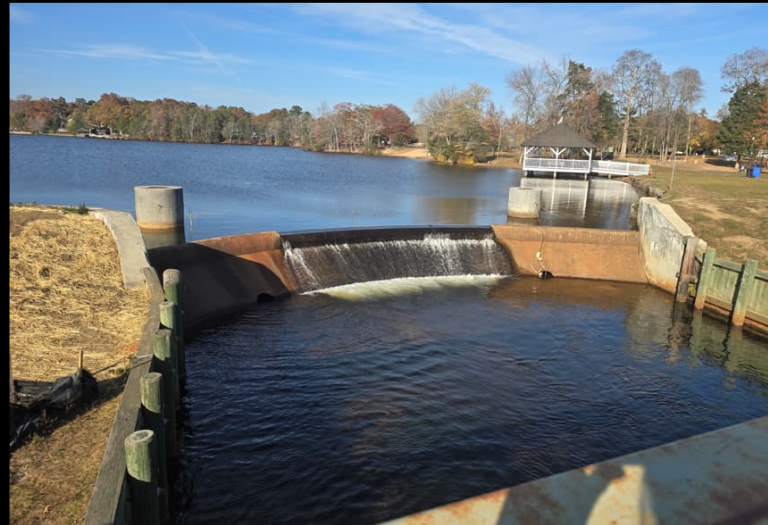
**SPILLWAY LOOKING NORTH**

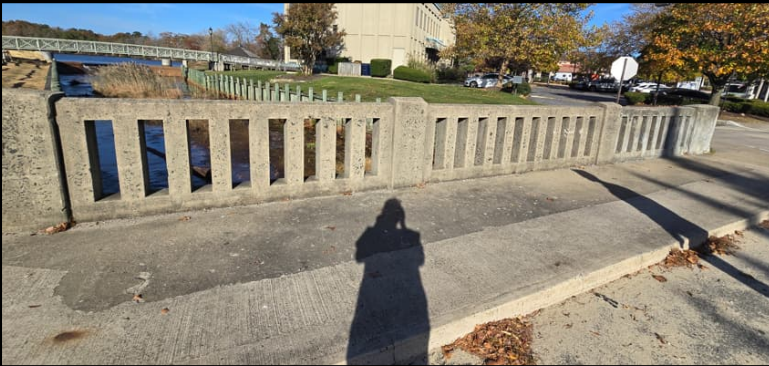
**EXISTING OPEN BALUSTRADE**

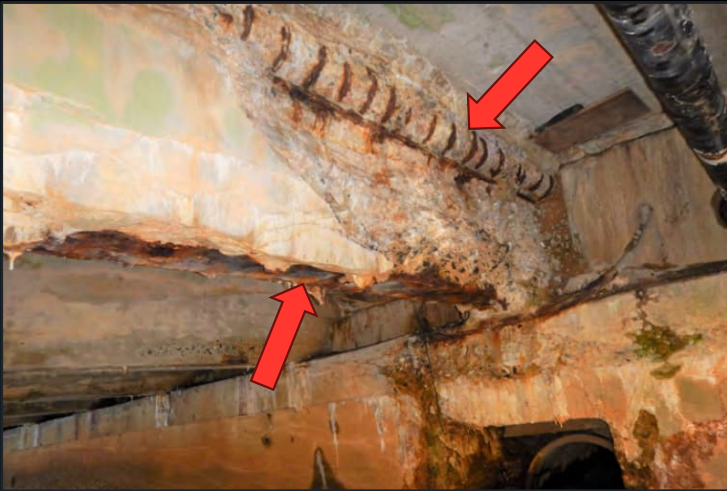
**GIRDER 2S NEAR EAST ABUTMENT**

2. The **superstructure is in satisfactory condition** due to the severe spalling and scaling of the concrete encasement at girder 2S and 11S, also some areas of exposed and heavily corroded bottom flange with remaining 7/8" section at girder 10S.

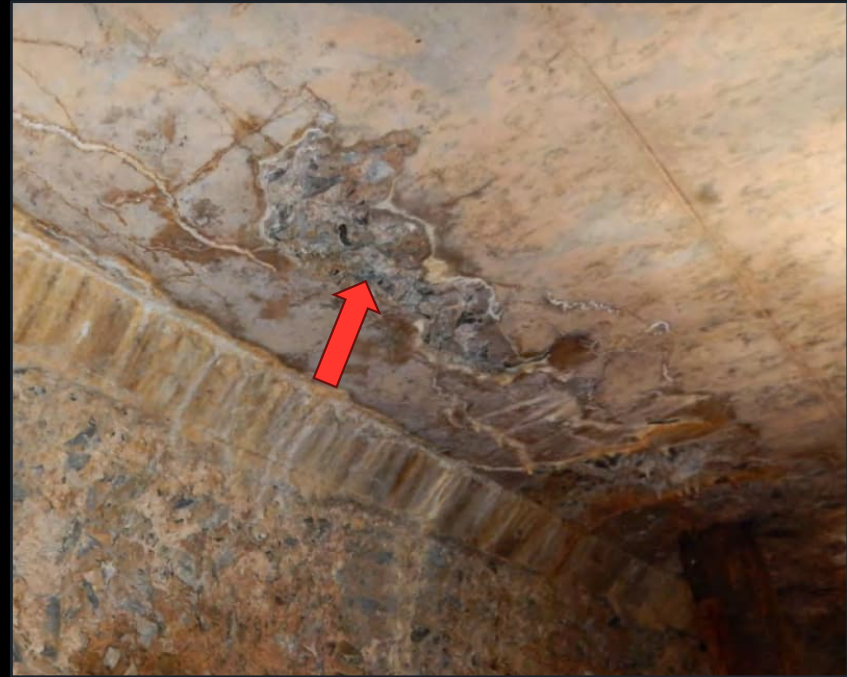
**UNDERSIDE OF DECK BAY 2S**

1. The **bridge deck is in poor condition** due to several large spalls and fine to medium cracks with light to moderate efflorescence on the underside of the deck.

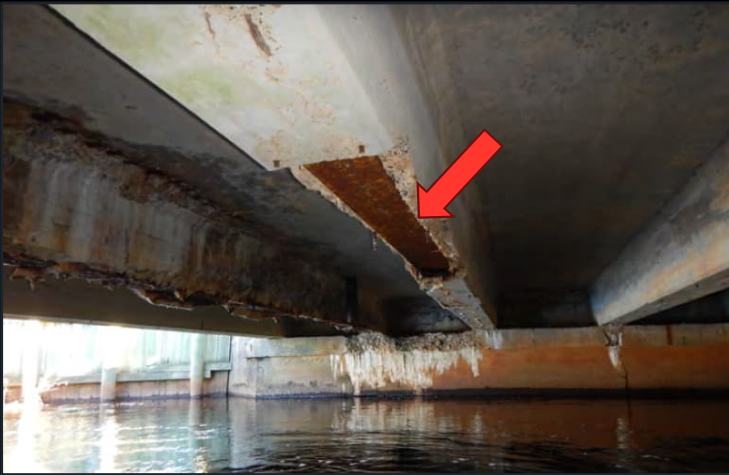
**GIRDER 10S**

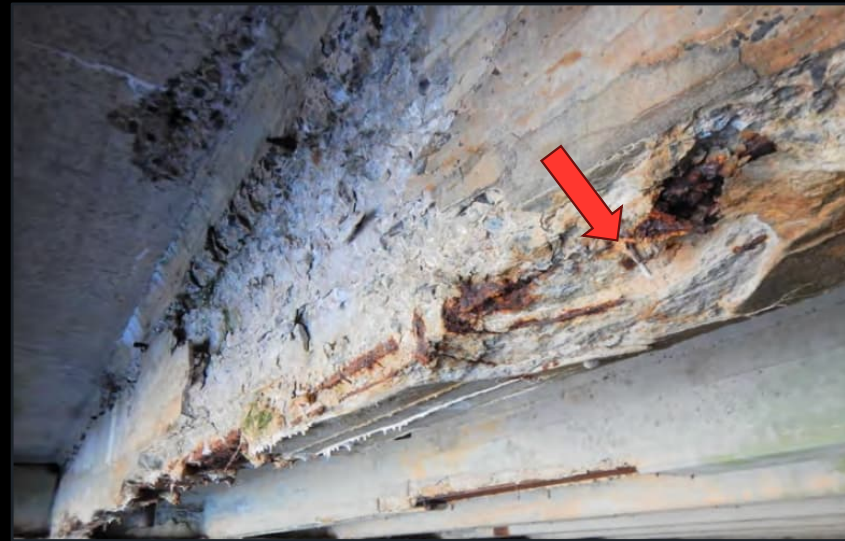
**NORTH FACE OF GIRDER 11S**

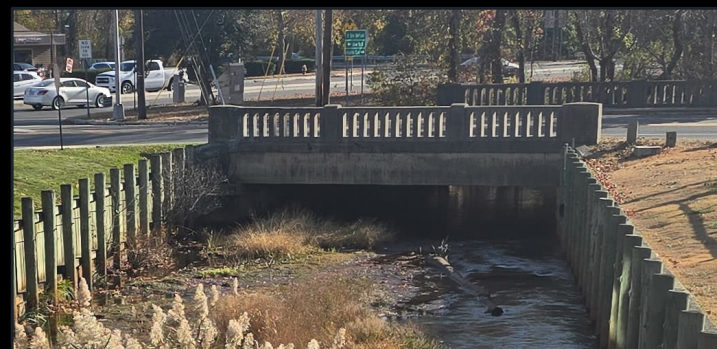
# Existing Bridge Elevation

ELEVATION LOOKING SOUTH

- *31'-3" single span encased structural steel beam bridge with a concrete cast-in-place deck*
- *Bridge is 64'-2" wide*
- *Spans over Mill Creek*
- *50 feet curb-to-curb width*
- *Varying travel lanes in each direction*
- *6 foot wide sidewalks on each side*
- *Underclearance over Mill Creek is about 2'-11" per Inspection Report*
